CLINICAL INSIGHTS

EPIC™ MITRAL AND EPIC™ SUPRA STENTED TISSUE VALVES

Three-Year Outcomes of Valve-in-Valve Intervention within the Epic™ Supra and Epic™ Mitral Valves in a Medicare Population

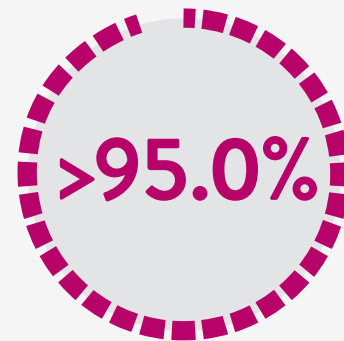
FREEDOM FROM VALVE REINTERVENTION AFTER VIV AT 3 YEARS

- ViV intervention was feasible in all valve sizes, including the 19mm Epic™ Supra (n=15) and the 25mm Epic™ Mitral (n=13) valves
- 3-year KM freedom from valve reintervention after ViV was >95% for both valve positions
- Freedom from HF rehospitalization was 73% and 70% for Aortic and Mitral positions, respectively at 3 years
- Survival at 3 years post ViV was 66% and 58% for Aortic and Mitral, respectively. This was comparable to contemporary findings at three years from the VIVID and Partner 2 Registries.^{2,3}

This real-world nationwide study of U.S. Medicare patients implanted with an Epic™ valve in the aortic and mitral positions demonstrates the feasibility of ViV in all valve sizes and **>95% freedom from reintervention** at 3-years.
